- Name: Aluminum Box Terminal Block
- Model: AL-BOXTB-10PT
- Rating: IK08

5. Test method used: IEC 62262:2002  
IEC 60068-2-75:2014

# TEST REPORT

Report No: SR-22-2032  
Page(9)/(9)Pages

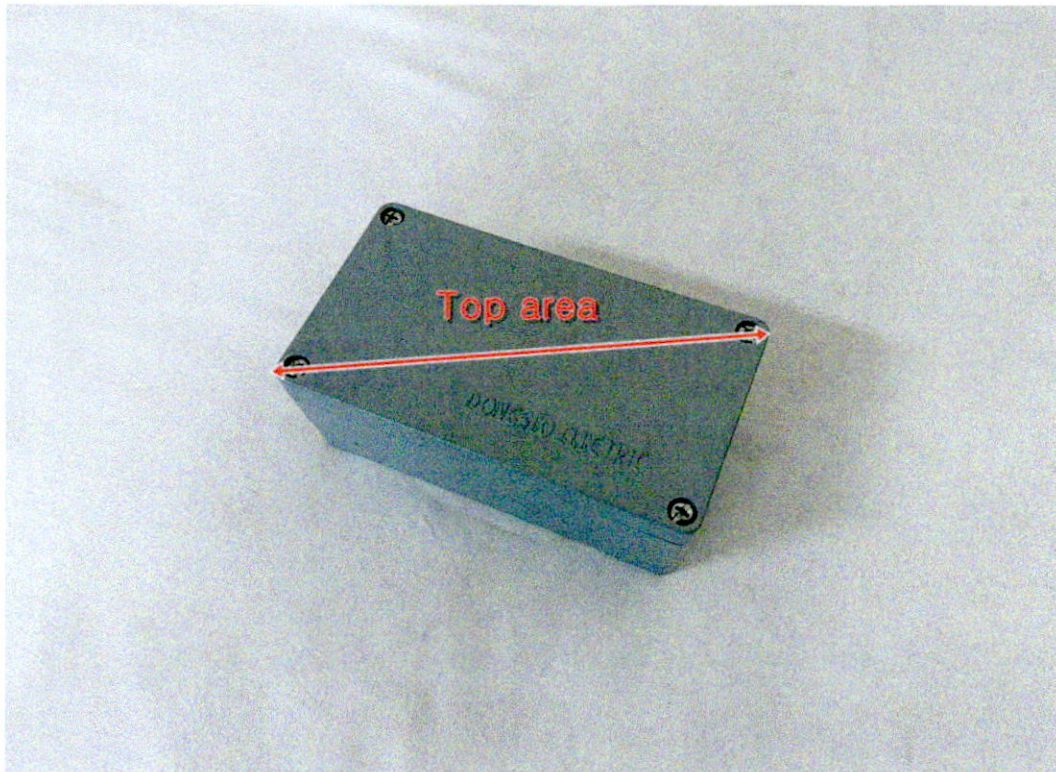
[Impact area]

| Impact area | Drop number | Position | Results | Remark |
|---|---|---|---|---|
| Note | Impact position: All surface of enclosure. | | | |

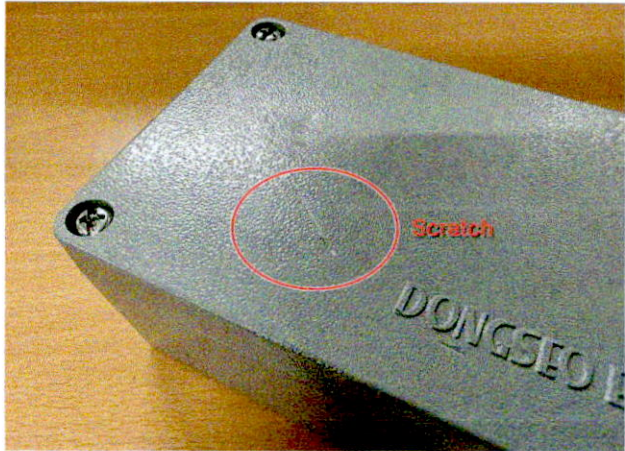
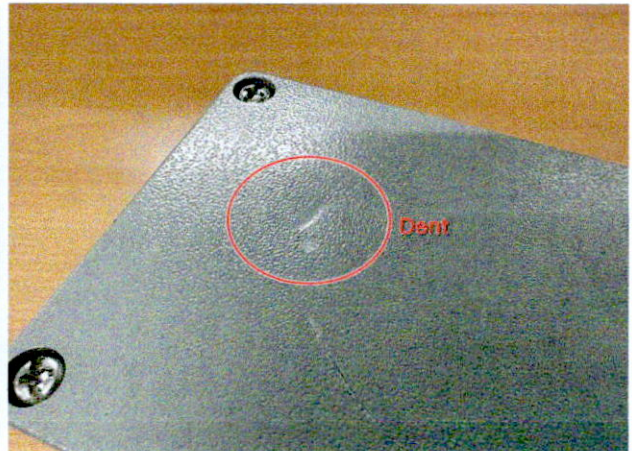
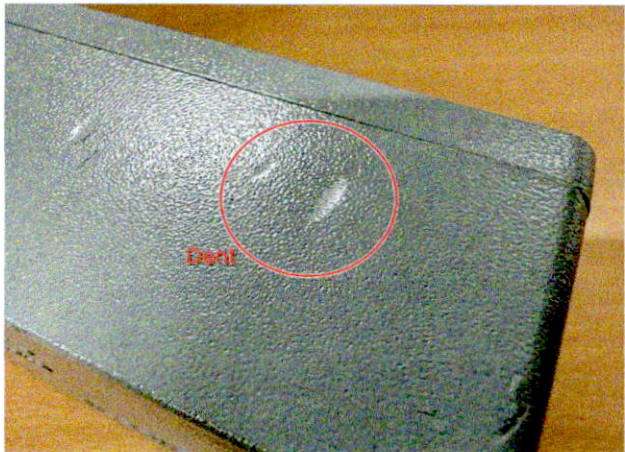
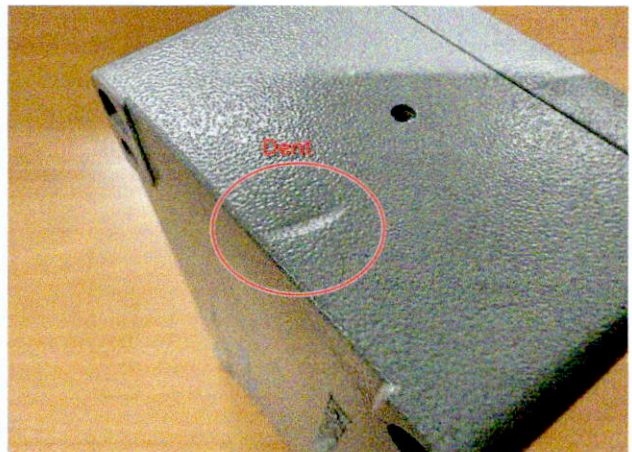
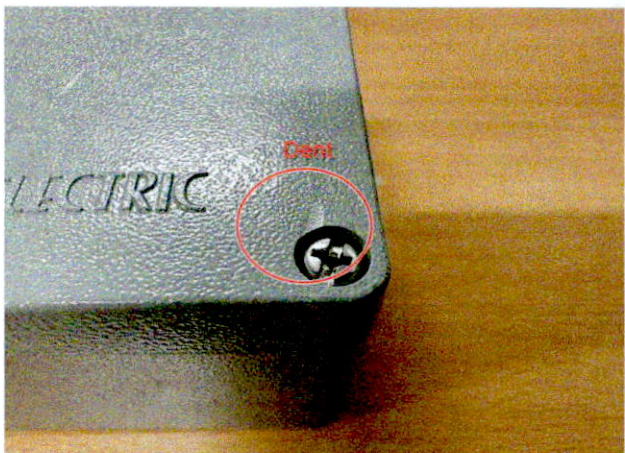
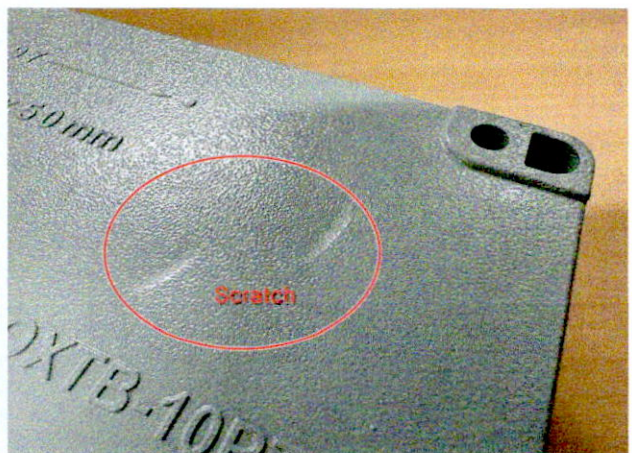
[After test]

| Impact area | Drop number | Position | Results | Remark |
|---|---|---|---|---|
| Top area | #1 | Front | There is no damage that could be dangerous. | See of photos after test |
| Body area | #1 | Front | There is no damage that could be dangerous. | |
| Bottom area | #1 | Front | There is no damage that could be dangerous. | |
